Russian EVA examines hole repair area on Soyuz MS-09

written by Chris Bergin | December 11, 2018

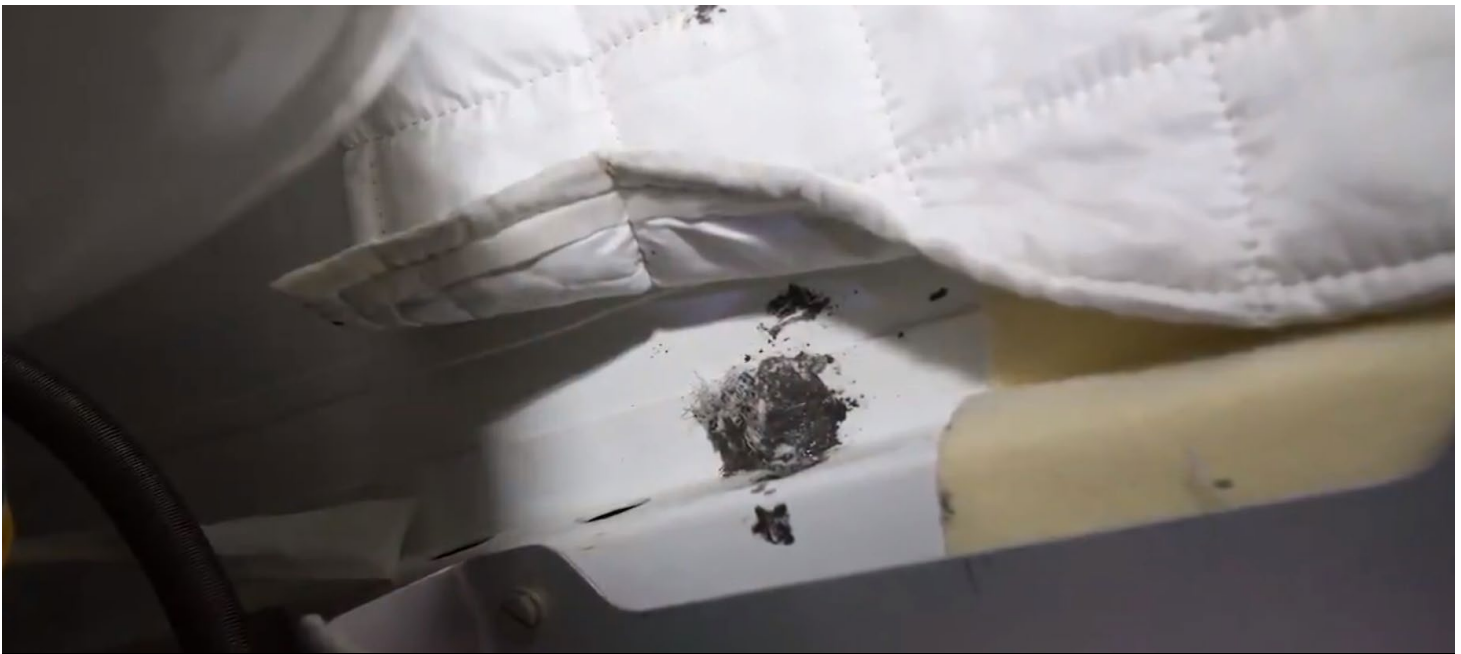
Image of the repair work – via NASA

However, the application of tape, patches and sealant appeared to work, with no further leak indications observed. While that solved the immediate issue, an investigation into the cause of the hole has failed to come to a firm conclusion.

With the leak located behind the toilet area in the orbital module, a plan was devised to patch the hole to at least stop the leak. This first involved astronaut Alexander Gerst placing his thumb over the hole, before Russian crewmembers evaluated a more permanent fix.

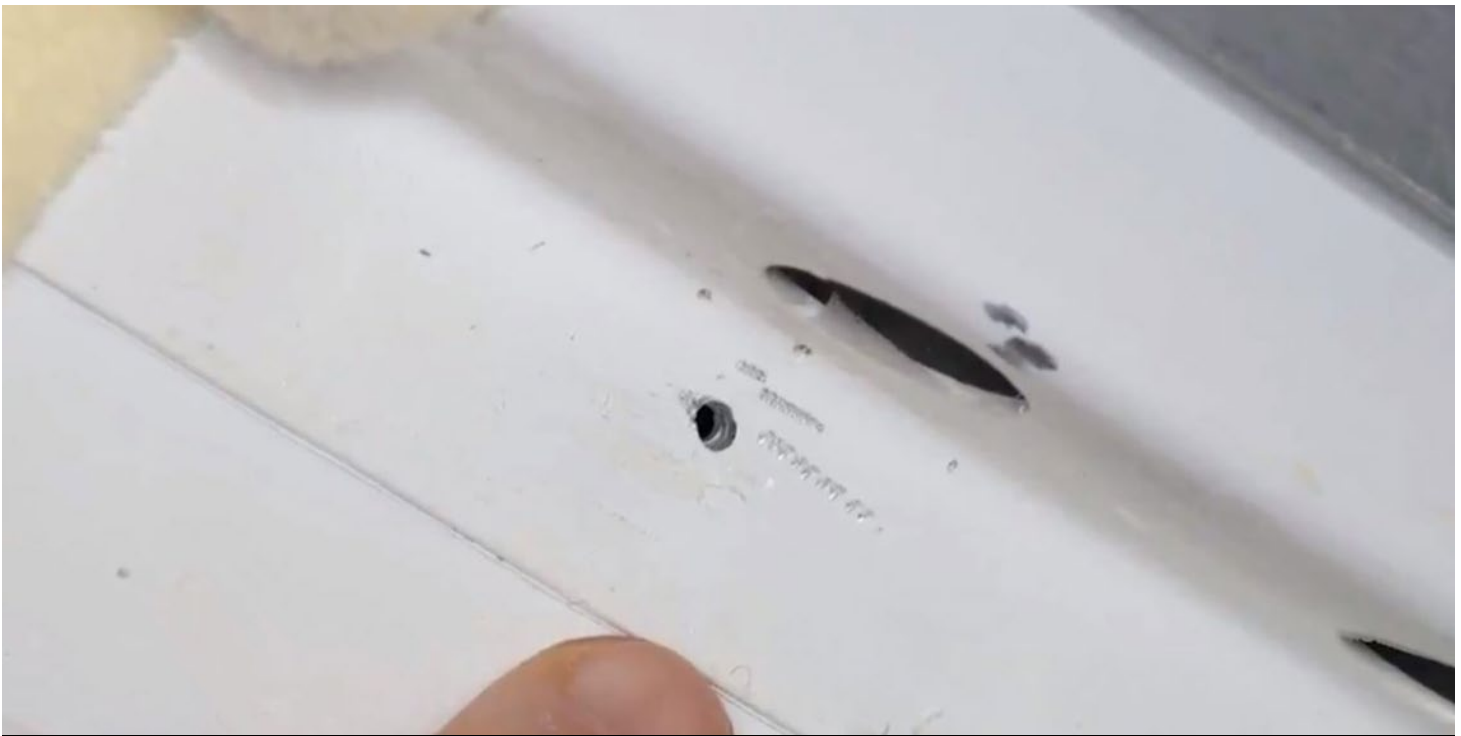
Doubts about the MMOD strike theory were noted when photos of the hole – first published on a NASA update video, before being edited out and the video reuploaded – made it obvious the hole looked man-made and alien to that of a usual MMOD impact site. Based on the photographs, it looked likely the hole was caused by a drill with the drill bit also marking the surrounding area.

The hole before it was repaired – via NASA (before being deleted, but saved by social media followers).

After some of the traditionally dramatic reports in the mainstream Russian media, some pointing to potential sabotage, the most likely theory of an error during the production of the Soyuz on the ground was deemed to be the most likely root cause. Russian quality assurance issues have plagued the industry for many years.

However, despite a State Commission investigation, no definitive explanation has been forthcoming. The only collaborating comments have been claims the hole was indeed created by a drill, but strangely accompanied by claims it wasn't known if the drill hole was caused by a deliberate or accidental action.
